November 3, 2020

Re: Applicant - GBRSTORZ, LLC Resubdivision of Anderson Sunnyside Farm 318 Kings Highway

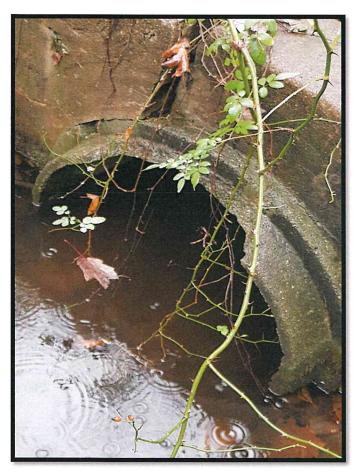
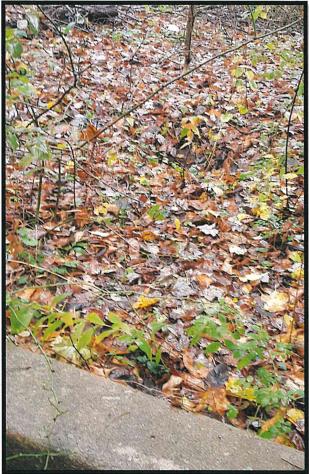
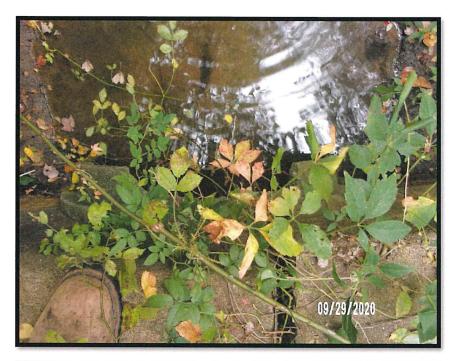
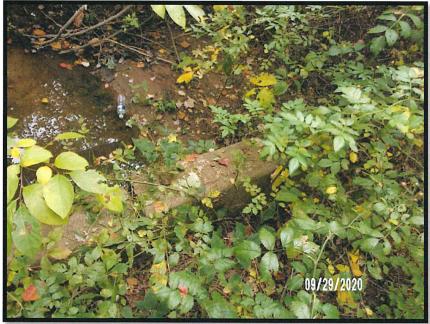
The drainage outlet consists of a 30" RCP pipe from a concrete headwall. A large crack exists in the headwall above the concrete pipe. A portion of the top of pipe exposed through the headwall has broken off. Silt, sediment & debris are visible at the outlet and downstream of the pipe which is limiting flow. At the time of inspection, the pipe was half full of water. It appears that a sink hole exists above the pipe approximately 10 feet west of the outlet (see pictures below).
