Wetland Delineation and Assessment Report

**318 Kings Highway
North Haven, Connecticut**

September 2020

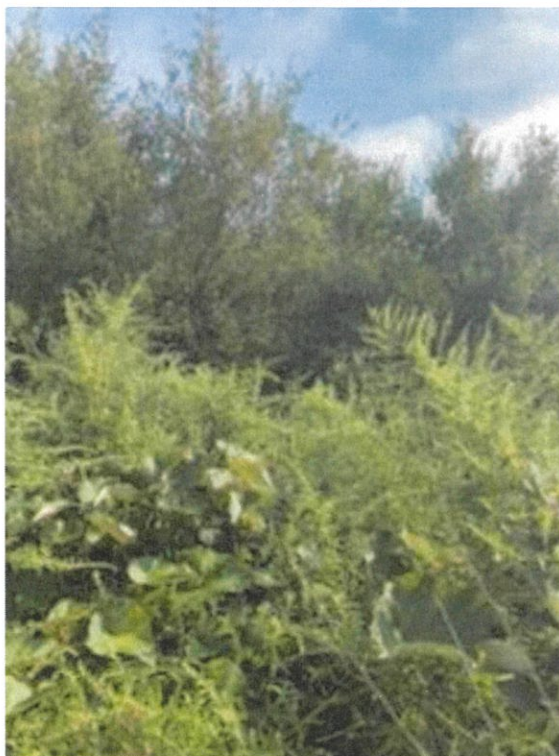
Upland area species include Eastern Red Cedar (*Juniperus virginiana*), Red Maple, Russian Olive (*Elaeagnus angustifolia*), Multi-flora Rose, Grape vine, and Raspberry (*Rubus spp.*). Upland areas are very heavily overgrown with invasive species and passage across the site required cutting tools.

Typical Upland Area

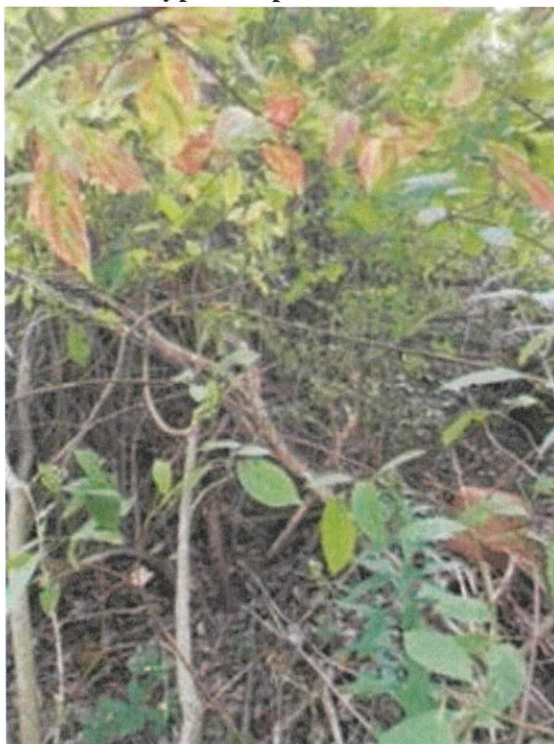
Typical Upland Area

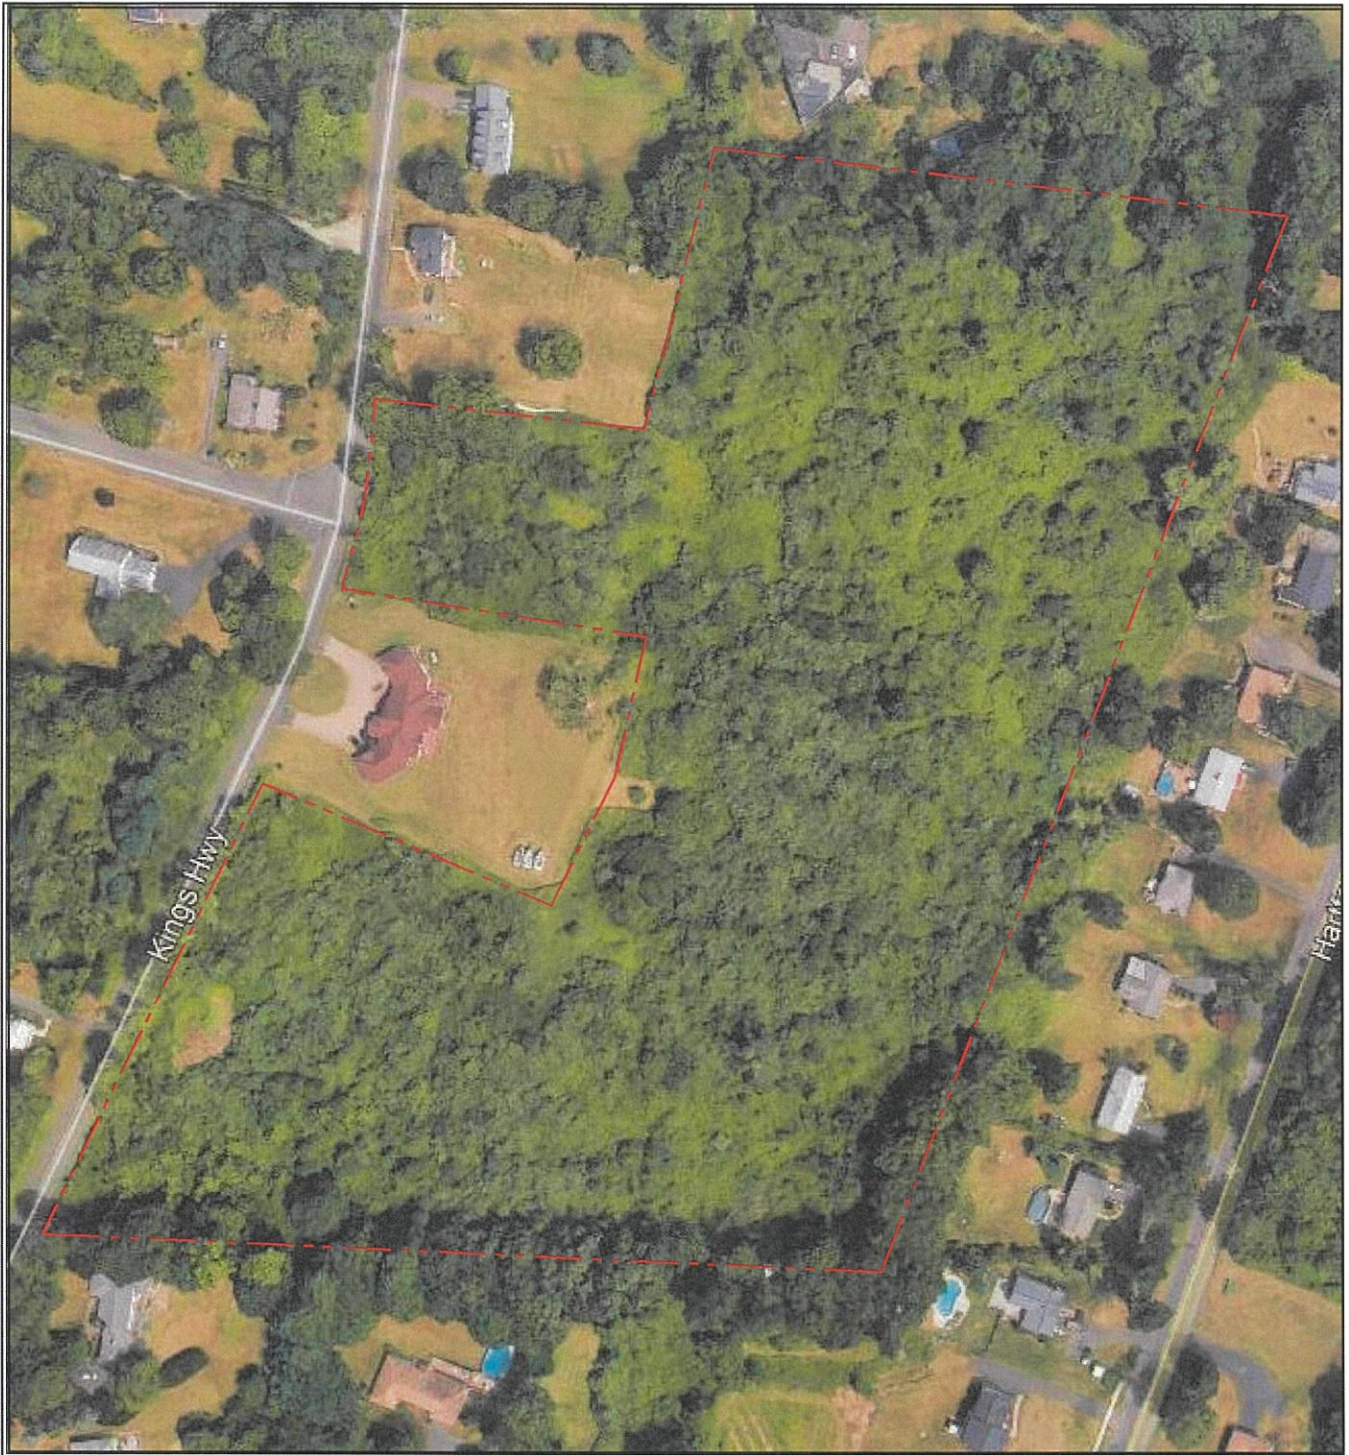
Figure 2 - Aerial Site Plan

A Site Location Map is provided as Figure 1. An aerial view is provided as Figure 2. Photographs are provided as Attachment A.

318 Kings Highway
 Tax Map 98, Lot 1
 North Haven, New Haven County, Connecticut
