**RE: Wetland and Watercourse Delineation
343 Clintonville Road
North Haven, Connecticut
MMI #2709-13**

As requested, Milone & MacBroom, Inc. (MMI) visited the property at 343 Clintonville Road in North Haven, Connecticut, to identify the boundaries of inland wetlands and watercourses. This letter includes the methods and results of the investigation, which was completed on May 24, 2019. In summary, wetland and watercourse systems on the property are comprised of Waterman's Brook, a perennial stream that drains to the Quinnipiac River, and abutting wetlands, which include 2.15 acres of red maple forested wetlands and a 0.20-acre farm pond. One small (0.0044-acre) vernal pool was identified north of Waterman's Brook within the interior of the red maple forested wetland.

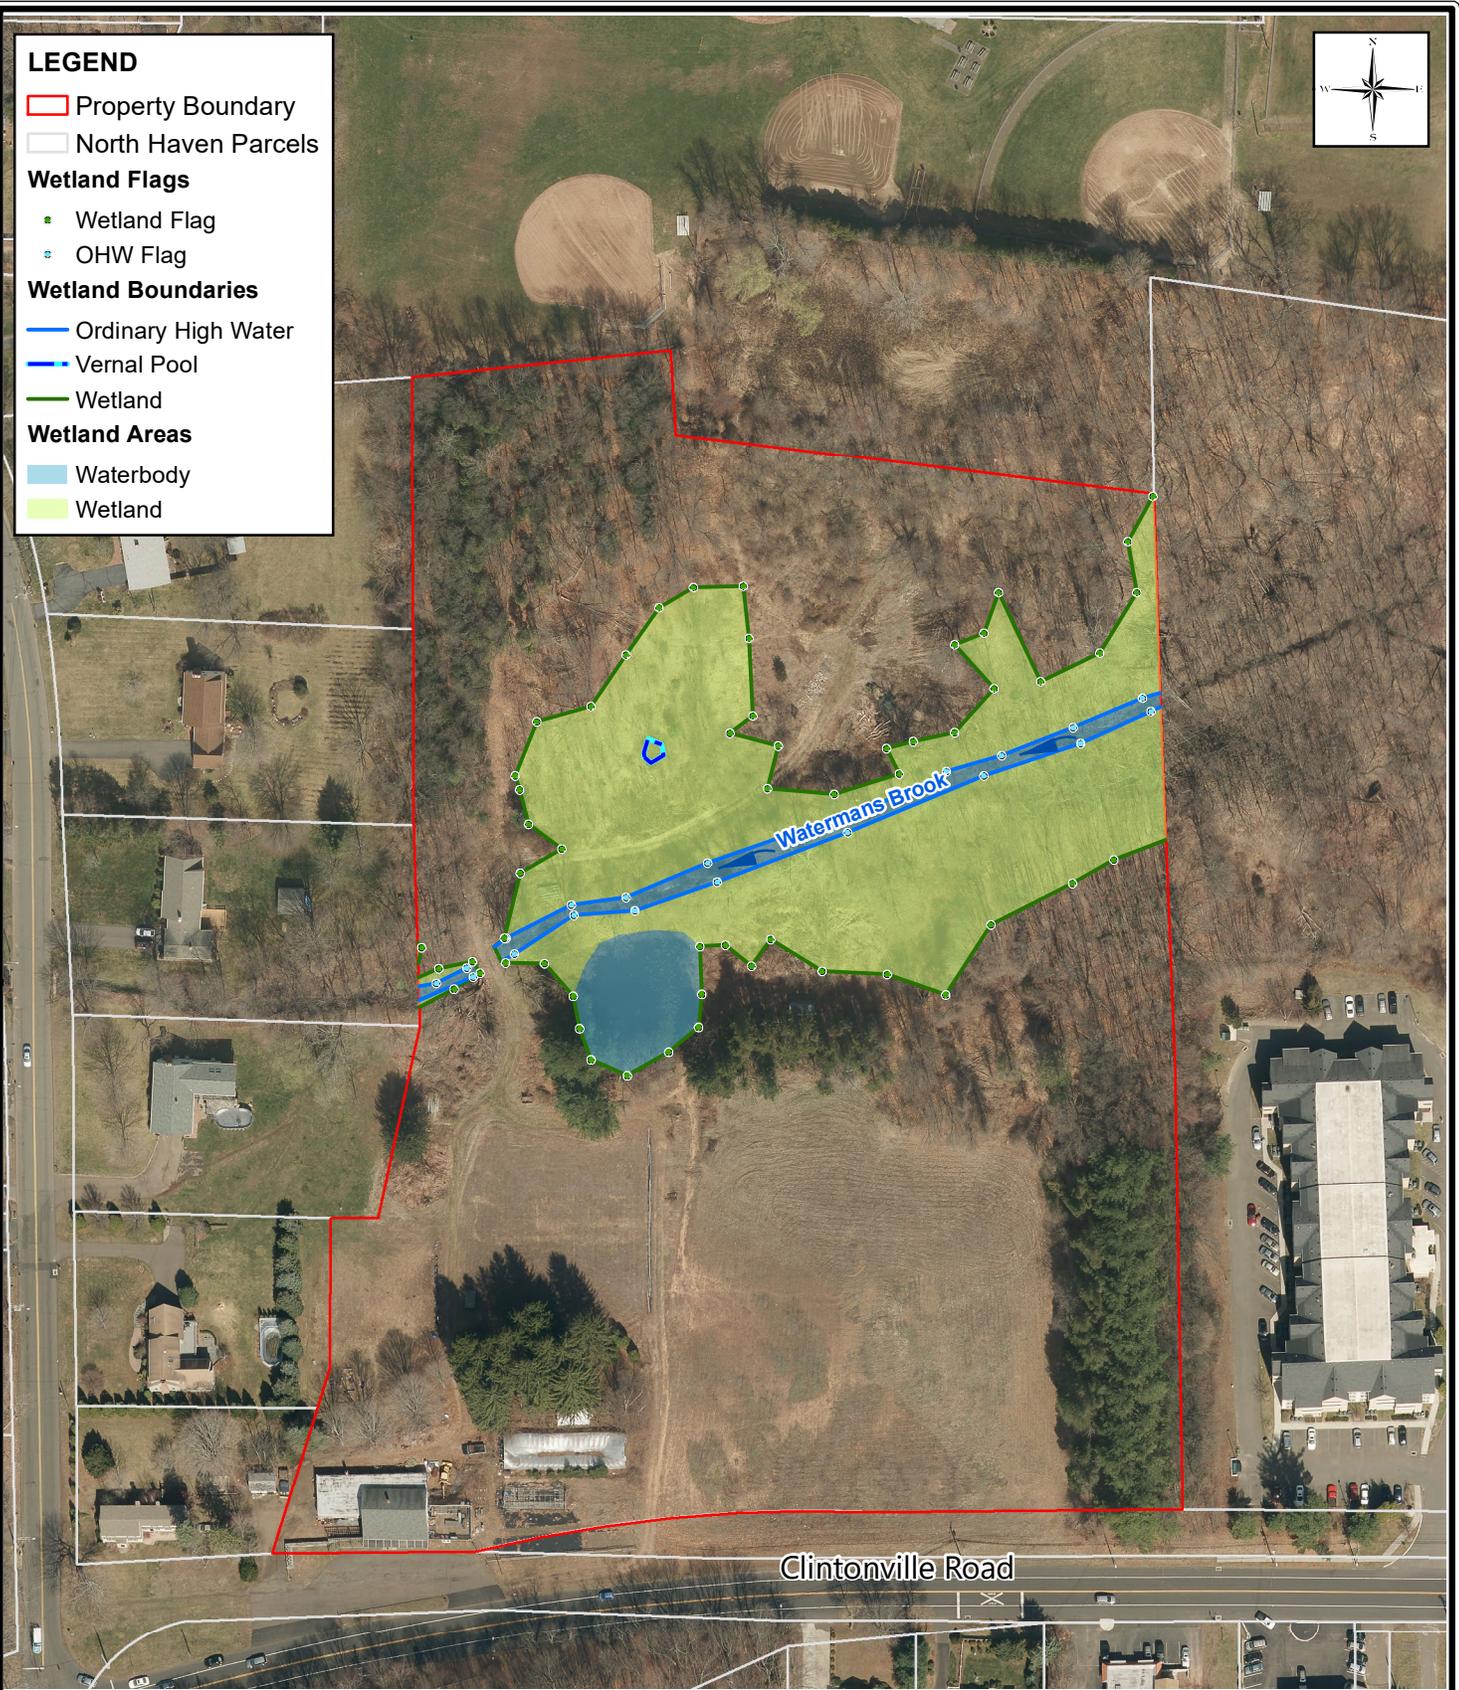
DRAWING NAME:
FIG. 2

Waterman's Brook is surrounded by 2.15 acres of red maple forested wetlands extending to the north and south (Figure 2). These wetlands receive hydrology from groundwater, runoff from adjacent uplands, and overbank flooding from Waterman's Brook. The wetlands are dominated by a red maple canopy and an understory of speckled alder (*Alnus incana*) and spice bush (*Lindera benzoin*) with a groundcover of skunk cabbage (*Symplocarpus foetidus*), cinnamon fern (*Osmundastrum cinnamomeum*), and jewel weed (*Impatiens capensis*).

One small (0.0044-acre) vernal pool was identified within the delineated wetland boundary in the northwest portion of the wetland system. Wood frog (*Lithobates sylvaticus*) tadpoles, an obligate vernal pool species, were found within this pool during the site survey performed by MMI on May 24, 2019. The pool appeared to have sufficient hydrology for complete development of these tadpoles to metamorphs prior to seasonal drying. No other wetland areas on site contained sufficient hydrology to support vernal pool species breeding and development.

WETLAND DELINEATION
 CLINTONVILLE ROAD PARCEL
 343 CLINTONVILLE ROAD
 NORTH HAVEN, CONNECTICUT
 SOURCE: 2016 AERIAL PHOTO, CTDEEP, 2006

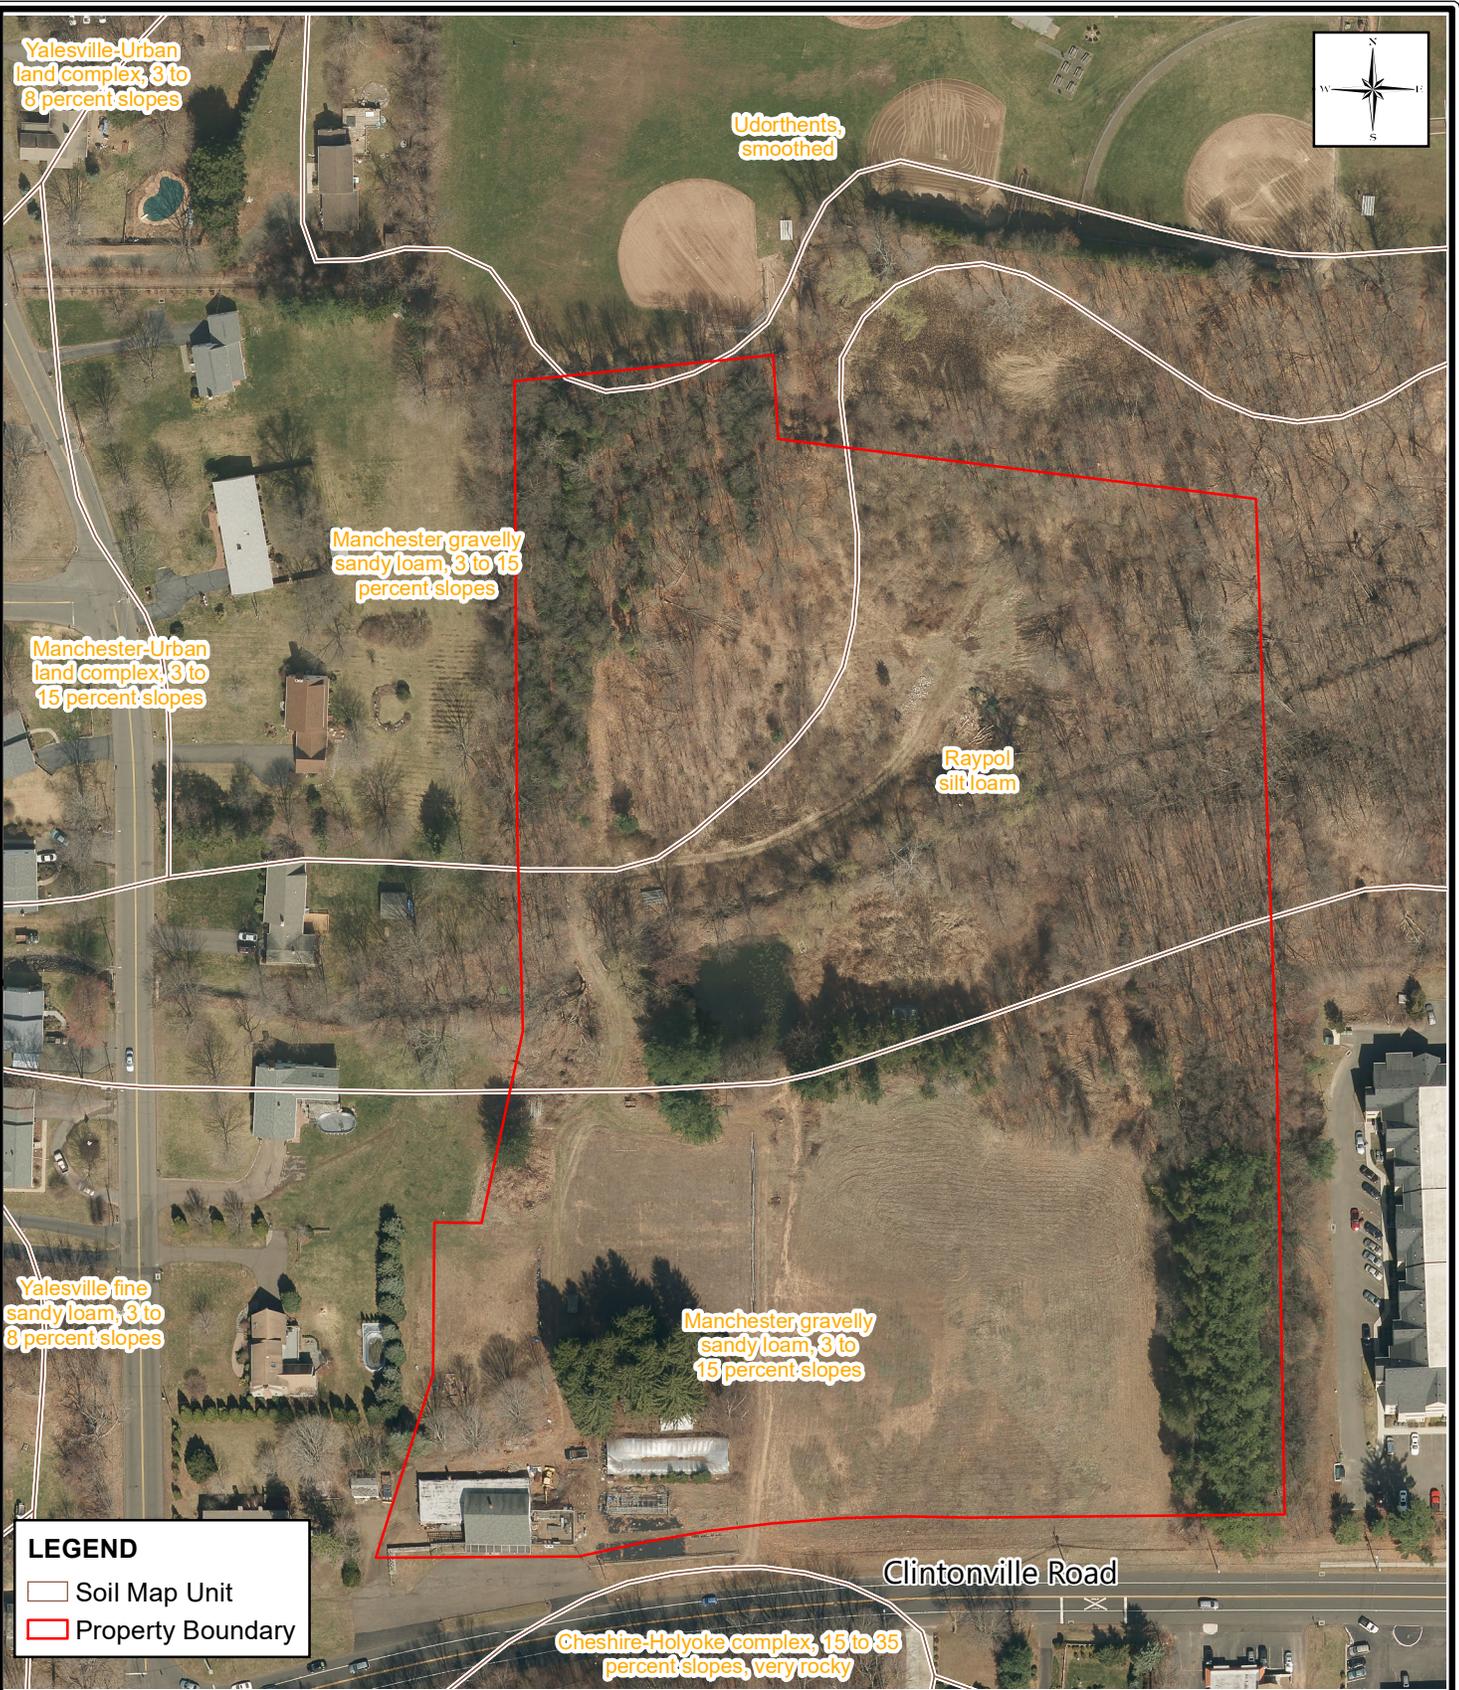
DRAWING NAME:
FIG. 3

Three soil map units were identified on the property (two upland and one wetland; Figure 3). Each map unit represents a specific area on the landscape and consists of one or more soils for which the unit is named. Other soils (inclusions that are generally too small to be delineated separately) may account for 10 to 15 percent of each map unit. The mapped units are by name, symbol, and typical characteristics (parent material, drainage class, high water table, depth to bedrock, and slope) (Table 1). These characteristics are generally the primary characteristics to be considered in land use planning and management. A description of each characteristic and its land use implications follows the table. A complete description of each soil map unit can be found in the *Soil Survey of the State of Connecticut* (USDA, 2005) and at <http://soils.usda.gov/technical/classification/osd/index>.

NRCS SOILS
 CLINTONVILLE ROAD PARCEL
 343 CLINTONVILLE ROAD
 NORTH HAVEN, CONNECTICUT
 SOURCE: 2016 AERIAL PHOTO, CTDEEP, 2006
